mysyara Multi-Point Vehicle Inspection

Received By	HADI HASAN
Make	FORD
Model	MUSTANG (1966 - CLASSIC)
Plate #	N/A
Chassis/Vin #	6F087143964
Mileage	N/A
Registration Exp.	N/A
Received T/D	27/01/22
Delivered T/D	02/11/22

Mechanical and visual inspection

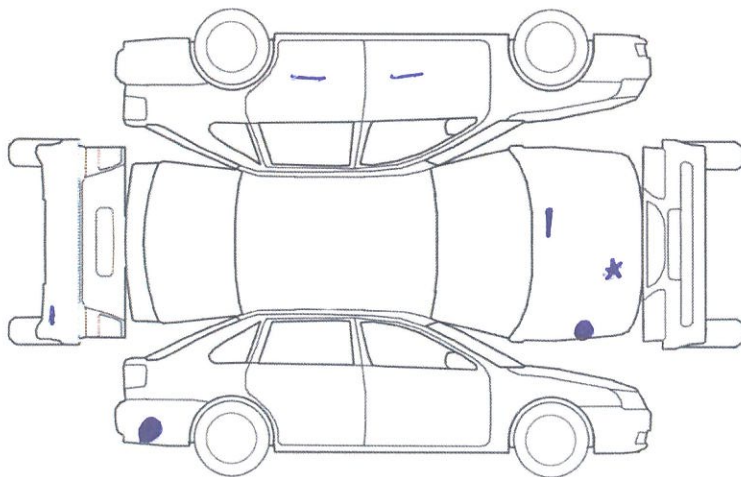
- Comments:
- Left Side Both Doors Scratched (Very Minor) -
 - Bonnet (Minor Scratched) -
 - Bonnet Paint Peeled (Minor) •
 - Bonnet Paint Cracking (Minor)*
 - Rear Right Fender Paint Peeled (Minor) •
 - Rear Bumper very minor scratch (need polish) •
